Case Study

Cable fault prevented: Saudi Electric Company, Jeddah

February 2016

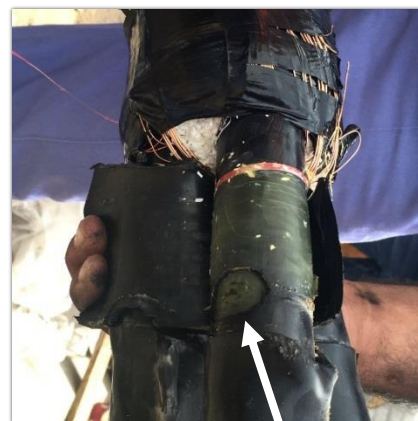
The examination showed extensive PD damage around the trifurcating point of the termination. The image to the right shows the damage caused to the cable. Maintenance was carried out and the termination was replaced, the recorded PD levels were reduced from 5000 pC to under 1000 pC.

Signs of PD activity on cable

Repairs were carried out which meant the termination needed to be replaced. The circuit was then re-energized and tested again. The test showed that the defect that had been causing high levels of PD had been removed and a potential in service failure was avoided.

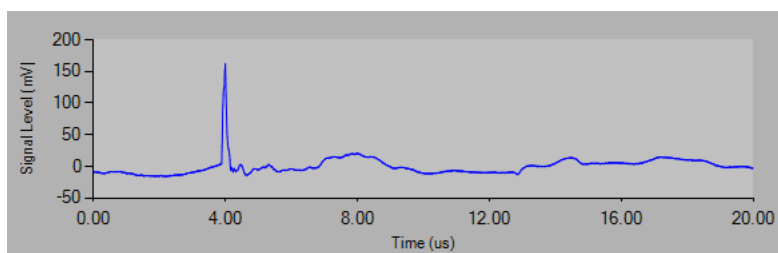
As part of their routine preventative maintenance schedule, Saudi Electricity Company (SEC) carried out some online cable PD testing using the Iona (online cable PD testing unit). Engineers found that there were very high readings for PD. With this information, the network was switched out and the cable termination was inspected.

Wave shape of discharge before maintenance was carried out

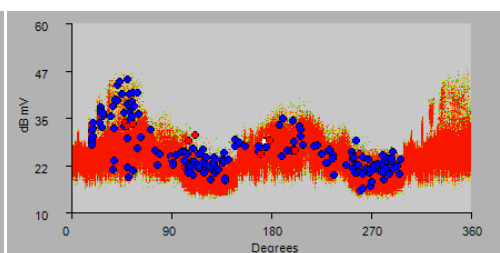
Phase Resolved PD pattern

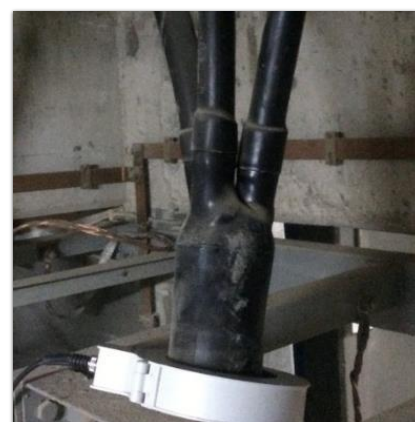
Trifurcating termination replaced
